{NASA-CR-153935} RESULTS OF  
GRAPHITE-POLYIMIDE ISOGRID PANEL TESTING  
Interim Report {Old Dominion Univ. Research  
Foundation) 57 p HC A04/MF A01 CSCL 11D

## RESULTS OF GRAPHITE-POLYIMIDE ISOGRID PANEL TESTING

Interim Report

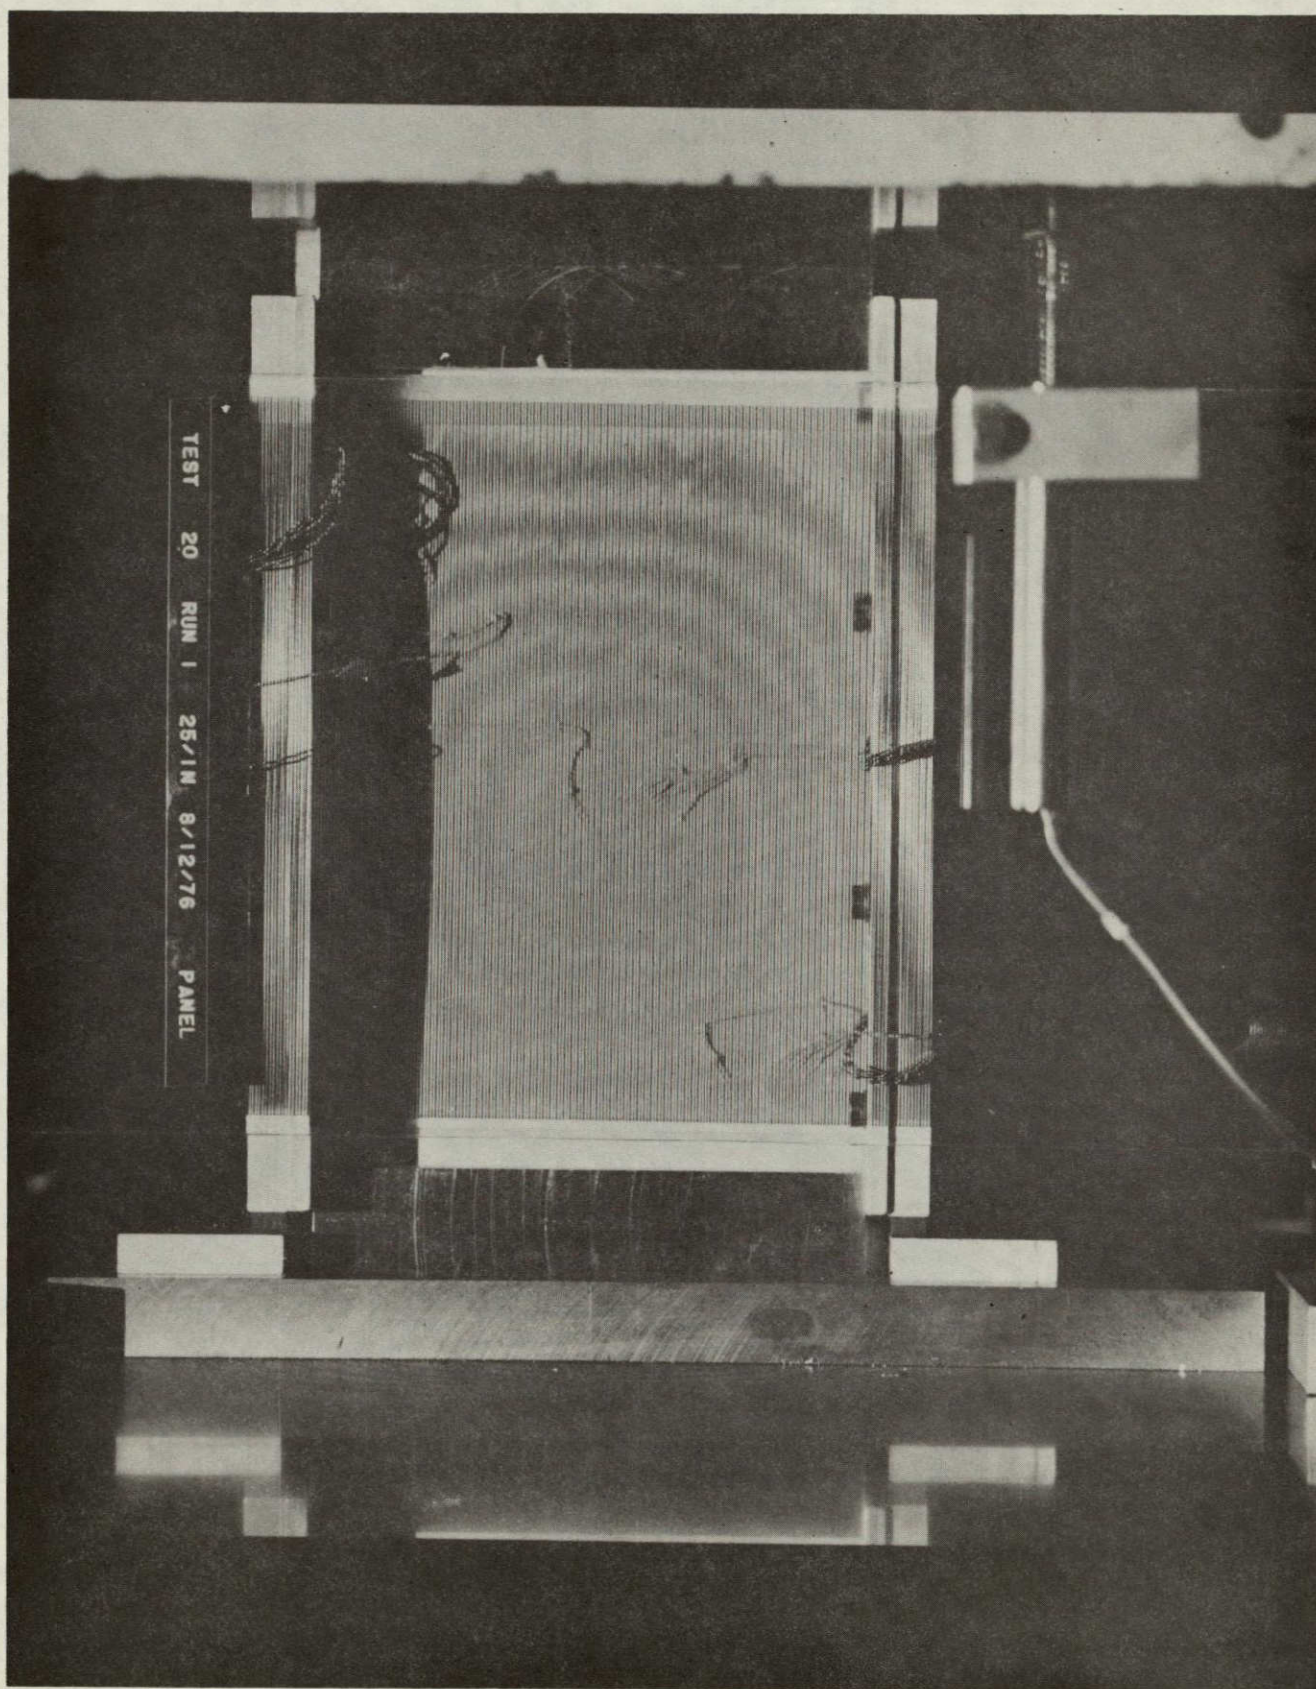
Figure 33. Moiré fringe pattern on panel 9 at intermediate load level.

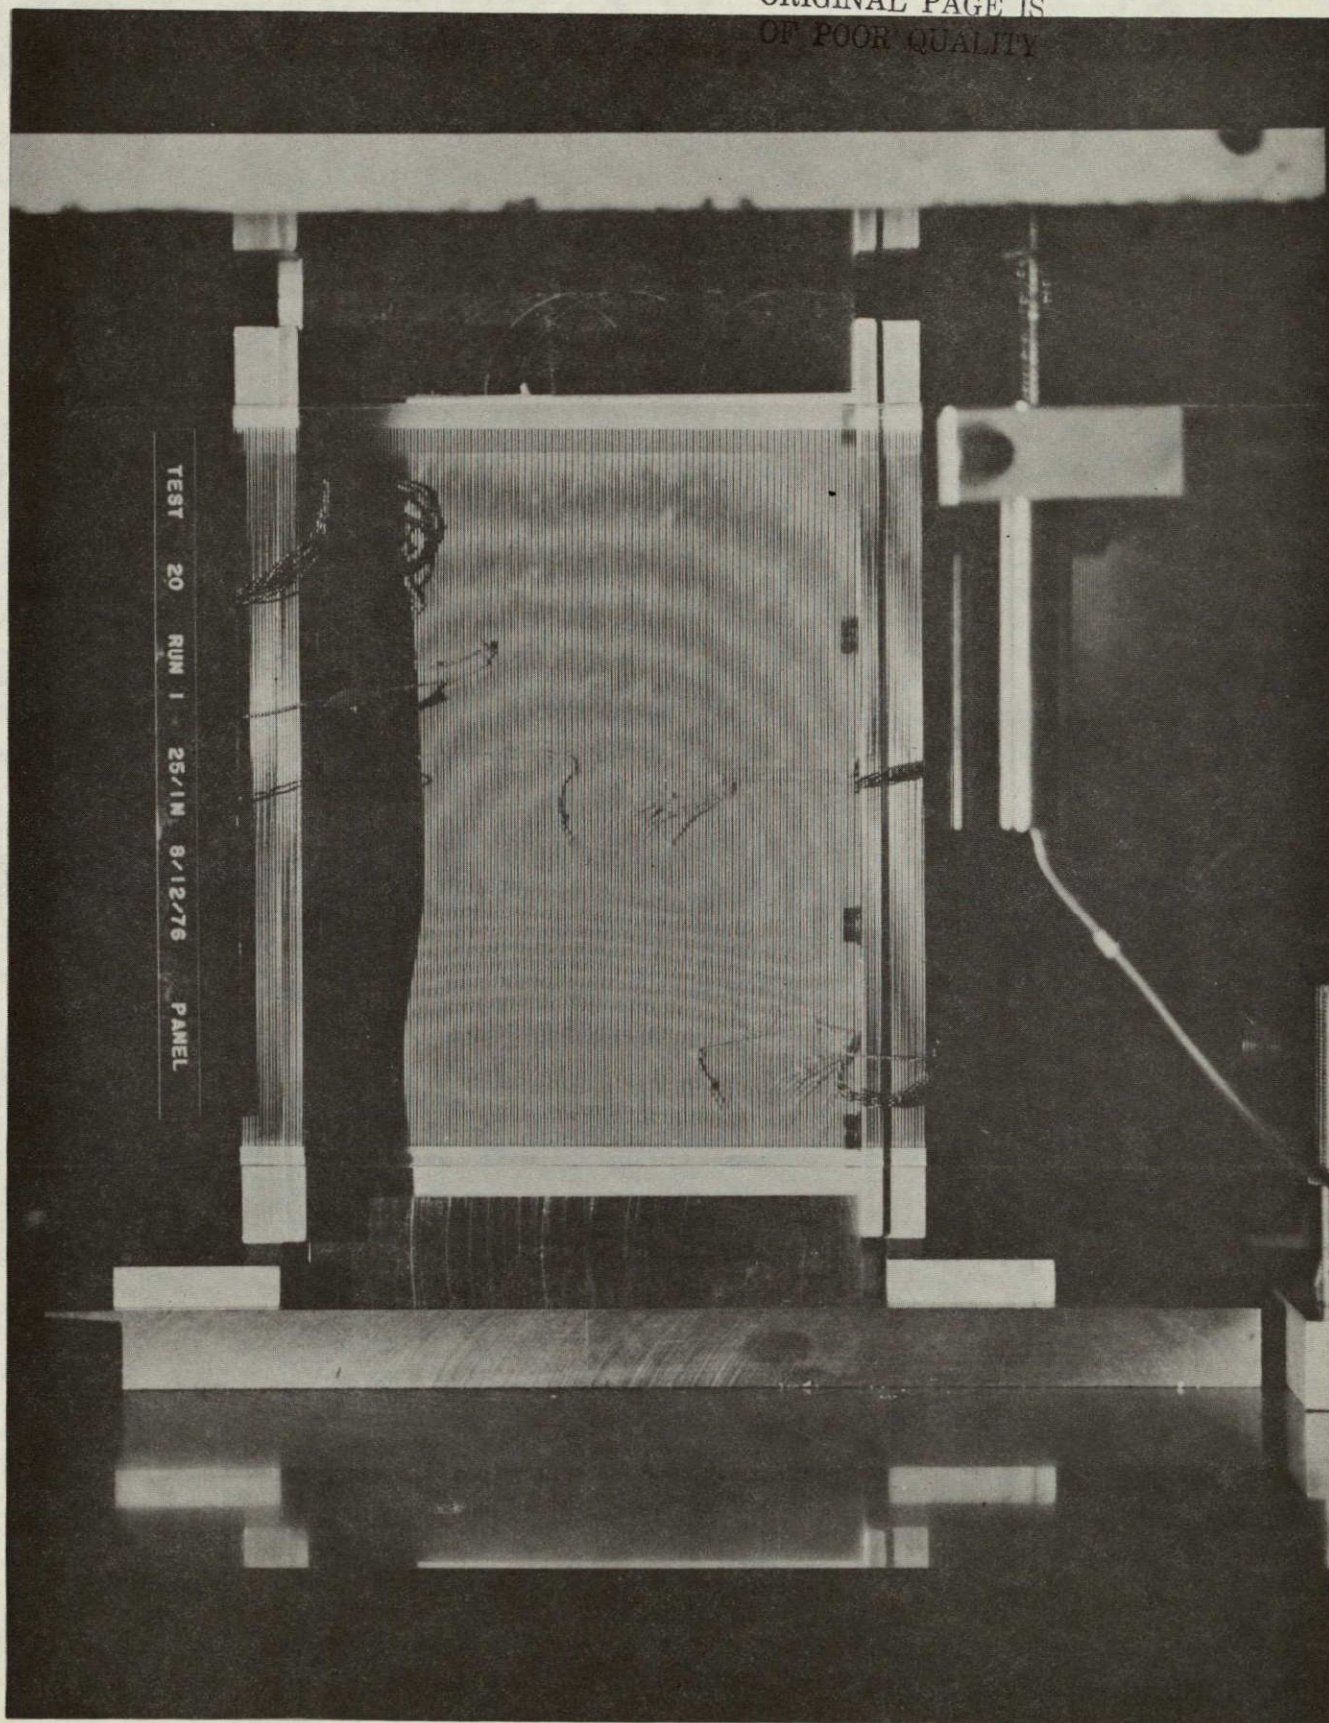
Figures 32, 33, and 34 show the Moiré fringe patterns at 3 load levels. Figure 32 shows the fringe pattern with no load. Theoretically there should be no fringe pattern with no load but surface irregularities of the panel skin and lack of parallelism between the grid master plate and the panel result in initial fringe patterns. Apparent also in this photograph, to the right of the panel, is the DCDT used to measure in-plane shortening of the panels. The DCDT actually measures the change in distance between the lower and upper heads of the loading machine. This set-up was similar on all three panel tests. Figure 33 shows the fringe pattern at an intermediate load level. The dark, wide vertical line on the left of the panel is the shadow from the knife edge support. Recalling that the fringes measure displacement slopes across the panel, it is evident that the out-of-plane deflections are quite symmetric across the panel. However, there is a dissymmetry in the slopes from top to bottom, with the center of the concentric fringe pattern being closer to the bottom. At lower load levels the dissymmetry was more pronounced. Figure 34 shows the fringe pattern after debonding occurred.

Figure 34. Moiré fringe pattern on panel 9 at panel failure.

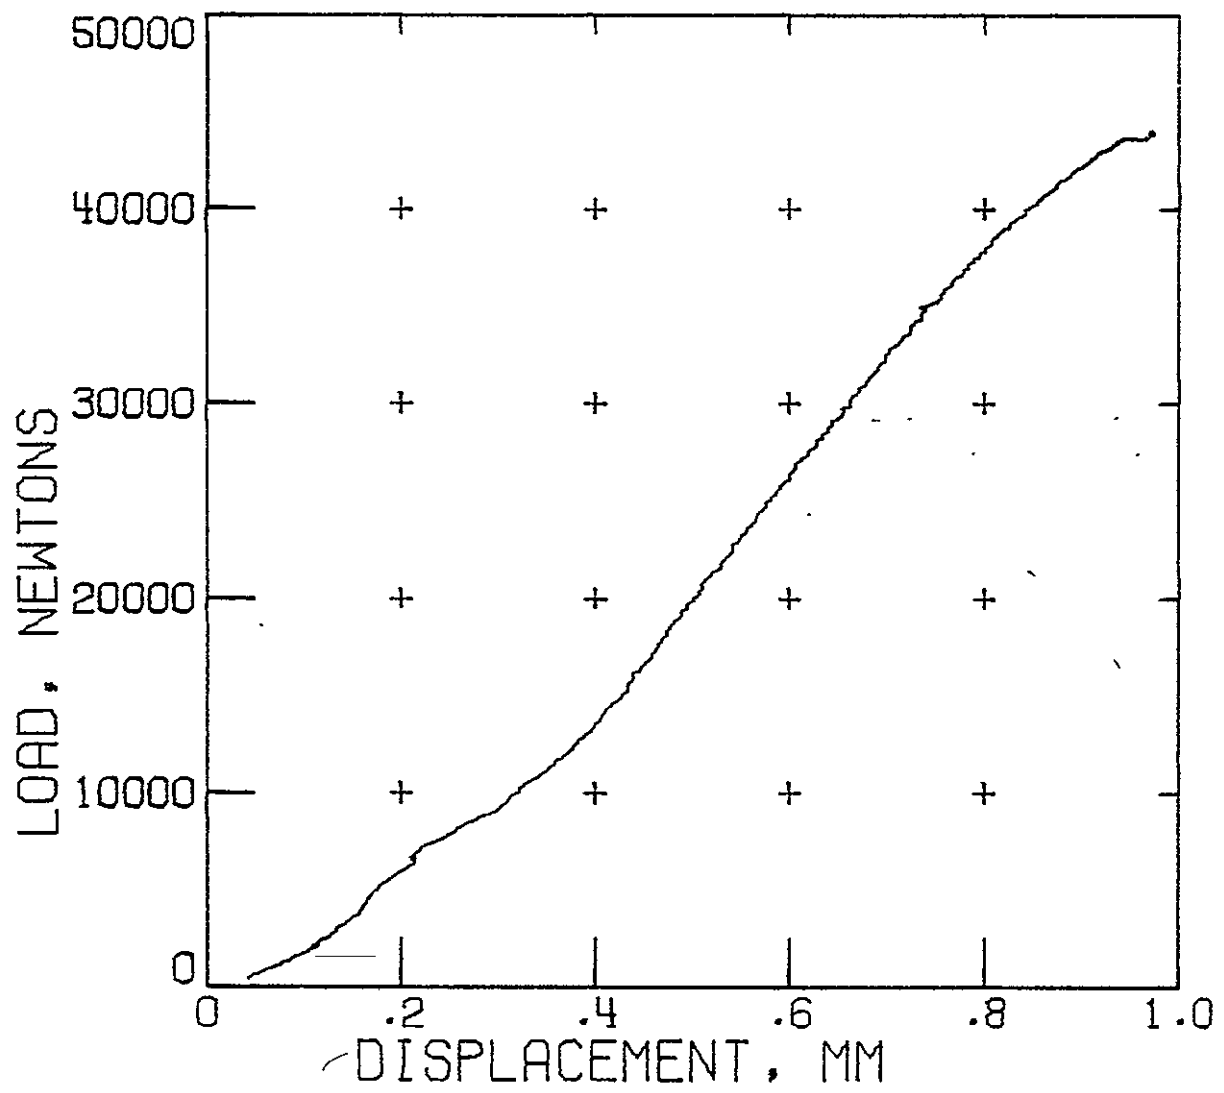
Figure 35. In-plane load-deflection behavior for panel 9.
